**INVESTIGATION TO DETERMINE THE FEASIBILITY
OF EMPLOYING LASER BEAM HOLOGRAPHY FOR THE
DETECTION AND CHARACTERIZATION OF BOND DEFECTS
IN COMPOSITE MATERIAL STRUCTURES**

FEBRUARY 1971

United Aircraft Research Laboratories

NASA CR-111836

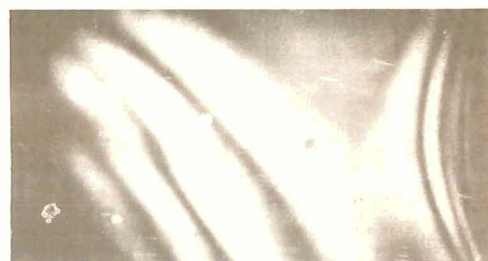
COMPOSITE BOND INSPECTION

HOLOGRAPHIC RECONSTRUCTIONS

(a) TEFLON TRIANGULAR FLAW – BORON EPOXY PREPREG AND ALUMINUM
ULTRASONIC EXCITATION FREQUENCY – 90 KHz

(b) CAVITY & MYLAR DISC FLAW – BORON EPOXY PREPREG AND ALUMINUM
ULTRASONIC EXCITATION FREQUENCY – 111 KHz

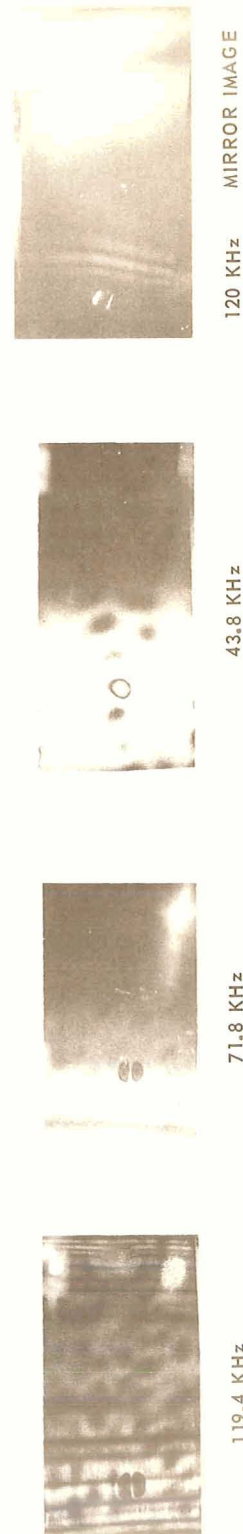
FIG. 6

TEST PIECE 5

(a.) FLAW LOCATION

(b.) FLAW IDENTIFICATION

Representative results obtained with this sample are presented in Fig. 6. The mode changes at the Mylar film flaws, particularly the larger one, are quite evident. The smaller one is only visible in the photo at the far right and appears nearer the bottom of the sample, rather than the top, since it is a mirror image of the actual test piece. The stainless steel bag flaw was not identifiable.

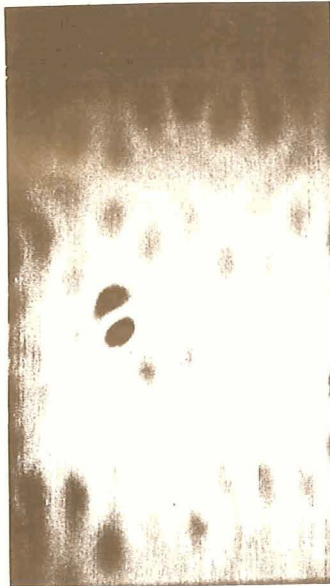
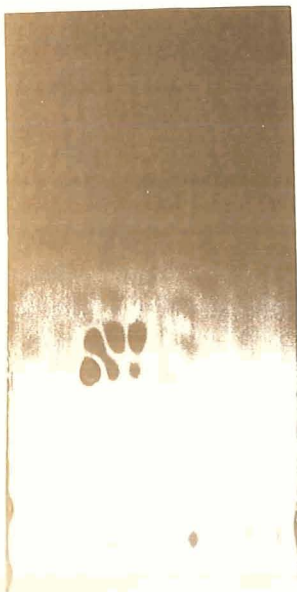
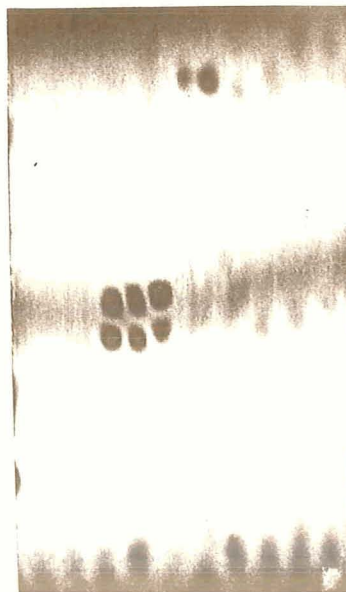
STAINLESS STEEL BAG FLAWS

TEST PIECE 7 - BORON PREPREG AND TITANIUM

(a) SCHEMATIC

(b) 72.5 KHz

(c) 83.5 KHz

(d) 107.0 KHz

- Test Piece 7. Three programmed rectangular flaws (0.5 x 0.5 cm, 1 x 0.5 cm and 1 x 1 cm electron beam welded stainless steel bags) were incorporated in the sample by cutting out corresponding areas in the ply adjacent to the substrate and bonding five plies of boron epoxy prepreg to an 0.75 mm titanium substrate in a one-step process.

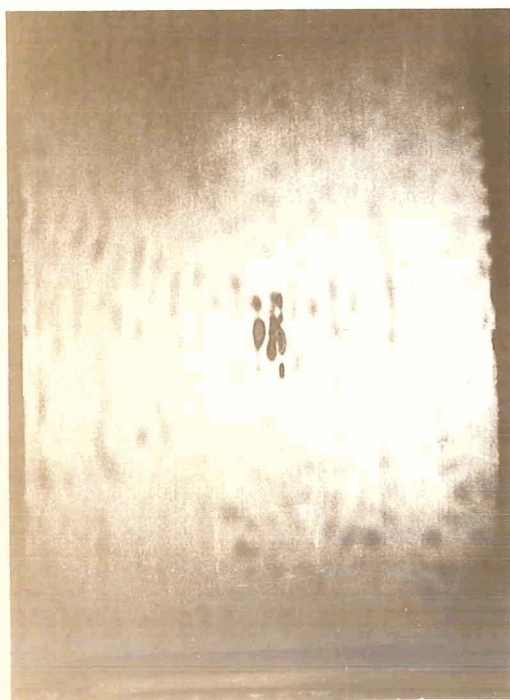
COMPOSITE BOND INSPECTION
STAINLESS STEEL BAG FLAWS
TEST PIECE 12-10 PLY BORON PREPREG AND ALUMINUM
FLEXURAL DRIVE

(a) FLAW LOCATION

(b) TRANSDUCER LOCATION

(c) FLEXURALLY INDUCED VIBRATIONS 156 KHz

(d) FLEXURALLY INDUCED VIBRATIONS 206 KHz

- Test Piece 12. Four programmed rectangular flaws were incorporated in a sample consisting of 10 plies of boron epoxy prepreg bonded to a 10 x 15 cm aluminum substrate of 0.8 mm thickness. The sample was fabricated by cutting out an area for each of the four flaws in various plies and inserting an electron beam welded stainless steel bag of equal area and bonding all 10 plies to the substrate in a one-step process. The flaws were positioned in the sample in the following manner: a 1.25 x 1.875 cm flaw in the first ply; an 0.625 x 1.875 cm flaw in the third ply; an 0.625 x 1.875 cm flaw in the sixth ply; and an 0.625 x 1.875 cm flaw in the ninth ply. The flaws in the first and sixth plies were near the ends of the test piece. The flaw in the third ply was at the center of the test piece with the long dimension (1.875 cm) perpendicular to the fibers, and the flaw in the ninth ply was located symmetrically over the flaw in the third ply, but with its long dimension parallel to the fibers.

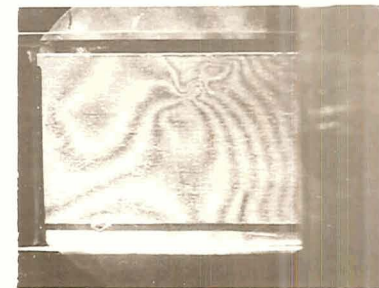
REAL TIME HOLOGRAPHIC OBSERVATION PHOTOGRAPHS
THERMAL STRESSING – BORON EPOXY PREPREG AND ALUMINUM
TEFLON TRIANGULAR FLAW.

(5 SEC)

(5 MIN)

(10 MIN)

(15 MIN)

ELAPSED TIME AFTER THERMAL STRESSING
